PRECISION INSPECTIONS, LLC

Residential Property Inspection Report

Property Address: 1 My Street
Any Town, NC 00012

FILE #: 100525one.
DATE OF INSPECTION: 5-25-2010.
CLIENT NAME: Jack & Jill Hill.
INSPECTION SITE: My Street.
INSPECTION SITE CITY/STATE/ZIP: Any Town, NC 00012.

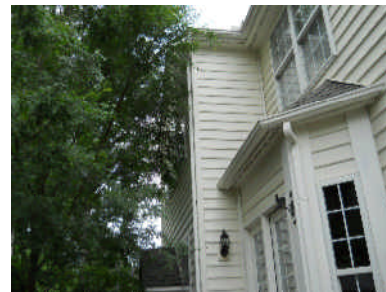
CONDITION: Tree limbs are touching or overhanging the roof and siding. Damage to the roof covering and structure is possible. Recommend limbs be removed by a qualified tree removal service.

1. Tree limbs are touching or overhanging the roof and siding. Damage to the roof covering and structure is possible. Recommend limbs be removed by a qualified tree removal service.

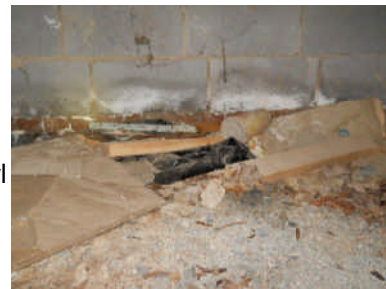
The crawlspace entrance is adequately sized. The crawlspace was inspected by entering and crawling through. Battery operated lights and a small probe were used to inspect components in the crawlspace. The crawlspace is in good condition, is fully insulated with fiberglass bat and has a vapor barrier on the crawlspace floor. There is wood debris in contact with the soil in the crawl space. This condition is conducive to wood destroying insects. Recommend removing all wood debris from the crawl space.

2. There is wood debris in contact with the soil in the crawl space. This condition is conducive to wood destroying insects. Recommend removing all wood debris from the crawl space.

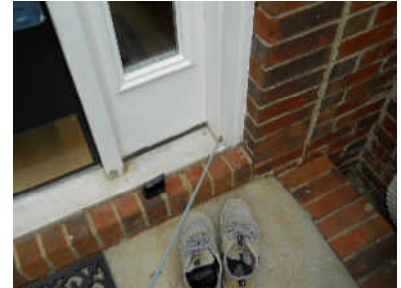
Type: Fiber Glass with insulated glass side lites.
Condition: Minor moisture damage is noted at the lower right portion of the right side light frame. Moisture damage at the lower portion of exterior door jambs is generally caused by exposure to rainwater. Where MINOR moisture damage is indicated, repairs are often possible using a plastic type filler, properly applied over sound surfaces.

3. Minor moisture damage is noted at the lower right portion of the right side light frame. Moisture damage at the lower portion of exterior door jambs is generally caused by exposure to rainwater. Where MINOR moisture damage is indicated, repairs are often possible using a plastic type filler, properly applied over sound surfaces.

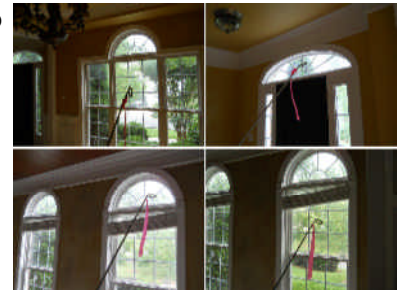
Condition: (a) The windows have lost their vacuum seal at: (1) top sash, dining room center, (2) top sash, dining room right, (3) front door transom, (4) study, half round of the left window, (5) study, right top sash, (6) study, left top sash, (7) left front bedroom, top sash, rear window, (8 & 9) master bedroom closet, top and bottom sash. As a result of losing this seal, condensation between the two panes creates a clouded or streaked appearance. At some time, if left in place, the window will turn opaque. Replacement is recommended since it is no longer serving its intended function. (b) The spring or slide that holds the window in the up position is not functional at: (1) study, left window, (2) left window of the right front bedroom, (3) right rear bedroom, (4) master bedroom closet. This condition could allow the window to slam closed causing glass breakage or injury to unsuspecting individuals. Recommend repair of all faulty counter balances.

4. (a) The windows have lost their vacuum seal at:(1) top sash, dining room center, (2) top sash, dining room right, (3) front door transom, (4) study, half round of the left window, (5) study, right top sash, (6) study, left top sash, (7) left front bedroom, top sash, rear window, (8 & 9) master bedroom closet, top and bottom sash. As a result of losing this seal, condensation between the two panes creates a clouded or streaked appearance. At some time, if left in place, the window will turn opaque. Replacement is recommended since it is no longer serving its intended function. (b) The spring or slide that holds the window in the up position is not functional at: (1) study, left window, (2) left window of the right front bedroom, (3) right rear bedroom, (4) master bedroom closet. This condition could allow the window to slam closed causing glass breakage or injury to unsuspecting individuals. Recommend repair of all faulty counter balances.

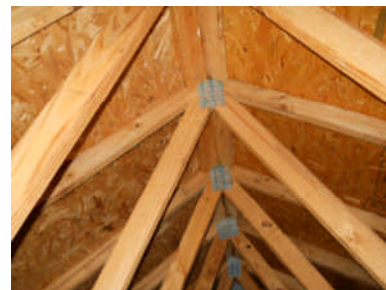
Attic is in good condition. The ridge vents are blocked by framing and do not function. Additional attic ventilation is recommended.

5. The ridge vents are blocked by framing and do not function. Additional attic ventilation is recommended.

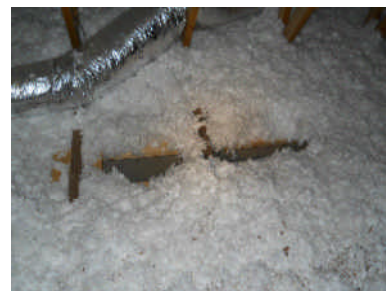
Fiberglass- Blown and Fiberglass batts. The wall chase cavity, near the second floor hall bath, is not covered by insulation. This will allow heating and cooling losses at the interior walls. Recommend covering the chase opening with drywall material and insulation.

heating and cooling losses at the interior walls. Recommend covering the chase opening with drywall material and insulation.

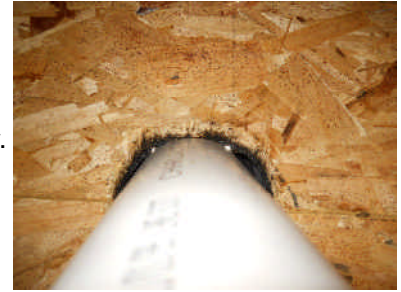
CONDITION: Several of the exterior roof plumbing boots have split. This can and has allowed water to enter around the area where the plumbing vent pipes go through the roof. Recommend all damaged boots be replaced. Recommend all repairs be made by a qualified Roofer. (See "Ceilings")

7. Several of the exterior roof plumbing boots have split. This can and has allowed water to enter around the area where the plumbing vent pipes go through the roof. Recommend all damaged boots be replaced. Recommend all repairs be made by a qualified Roofer. (See "Ceilings")

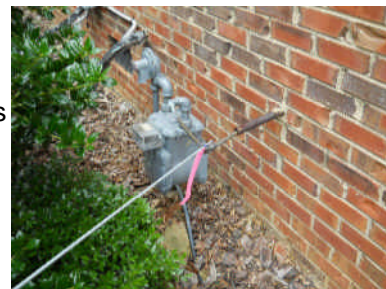
METER/TANK LOCATION-CONDITION: The gas meter is located on the exterior at the left elevation. Gas piping is not supported, at the regulator end supplying the water heater, in the garage. Recommend supporting the piping with straps to prevent accidental movement of the gas pipe.

9. The gas meter is located on the exterior at the left elevation. Gas piping is not supported, at the regulator end supplying the water heater, in the garage. Recommend supporting the piping with straps to prevent accidental movement of the gas pipe.

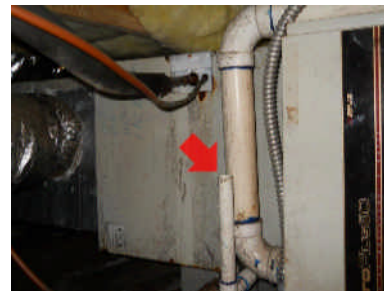
A condensate line is installed at the evaporator coils. The trap clean-out cap is missing. Without a cap the trap is defeated. Recommend replacing the missing cap.

10. The trap clean-out cap is missing. Without a cap the trap is defeated. Recommend replacing the missing cap.

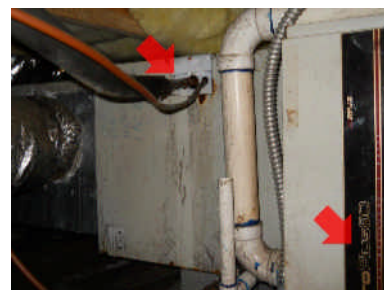
The insulation on the HVAC low pressure refrigerant line stops short of the sheet metal on the unit in the crawlspace. This condition will allow condensation to drip onto the main air handler cabinet and cause premature rusting of the unit. Recommend the low pressure refrigerant insulation be run all the way to and be flush with the sheet metal on the main air handler.

11. The insulation on the HVAC low pressure refrigerant line stops short of the sheet metal on the unit in the crawlspace. This condition will allow condensation to drip onto the main air handler cabinet and cause premature rusting of the unit. Recommend the low pressure refrigerant insulation be run all the way to and be flush with the sheet metal on the main air handler.

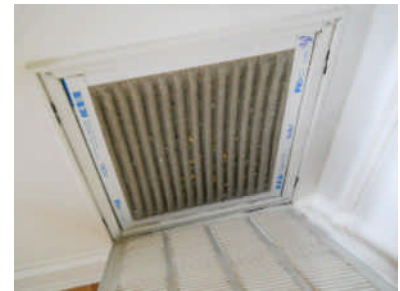
FILTER CONDITION: The filter is in need of cleaning or replacement. Replacing or cleaning filters every 30 days is recommended.

12. The filter is in need of cleaning or replacement. Replacing or cleaning filters every 30 days is recommended.

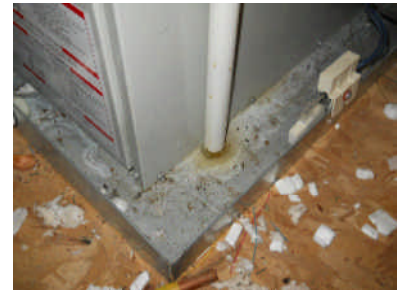
CONDENSATE LINE: A condensate line is installed at the evaporator coils. The condensate drain pan under the unit in the attic also has a condensate line and a micro switch installed. Condensate coming from the secondary drain suggest the primary drain is partly blocked. Recommend further investigation by a licensed HVAC contractor.

14. Condensate coming from the secondary drain suggest the primary drain is partly blocked. Recommend further investigation by a licensed HVAC contractor.

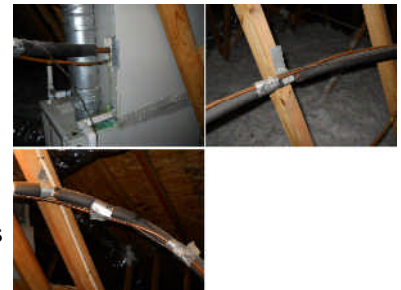
(a) The insulation on the HVAC low pressure refrigerant line stops short of the sheet metal on the unit in the attic. This condition will allow condensation to drip onto the main air handler cabinet and cause premature rusting of the unit. Recommend the low pressure refrigerant insulation be run all the way to and be flush with the sheet metal on the main air handler. (b) The HVAC low pressure refrigerant line is not fully insulated. Gaps in the insulation were observed. This condition will allow condensation to drip onto the ceiling causing staining and damage. Recommend the low pressure refrigerant insulation be run all the way to and be flush with the sheet metal on the main air handler.

15. (a) The insulation on the HVAC low pressure refrigerant line stops short of the sheet metal on the unit in the attic. This condition will allow condensation to drip onto the main air handler cabinet and cause premature rusting of the unit. Recommend the low pressure refrigerant insulation be run all the way to and be flush with the sheet metal on the main air handler. (b) The HVAC low pressure refrigerant line is not fully insulated. Gaps in the insulation were observed. This condition will allow condensation to drip onto the ceiling causing staining and damage. Recommend the low pressure refrigerant insulation be run all the way to and be flush with the sheet metal on the main air handler.

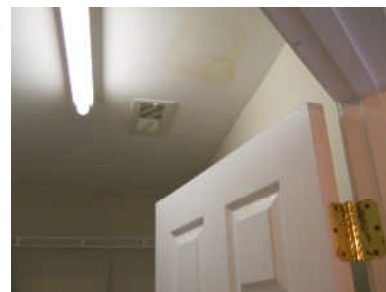
TYPE & CONDITION: The ceilings are covered with Drywall. Moisture stains were noted on the ceiling in the master bedroom closet. Stains are due to roof plumbing boot leaks.

19. Moisture stains were noted on the ceiling in the master bedroom closet. Stains are due to roof plumbing boot leaks.

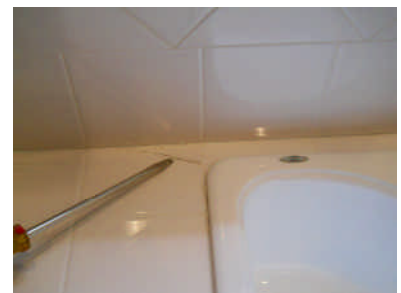
COUNTERS AND CABINETS: Cabinets are wood. Cabinets are functioning as intended. Counters are tile. Tile is cracked at the left rear corner of the sink. Recommend replacement of the cracked tile to prevent moisture damage to the wood sub surface.

21. Tile is cracked at the left rear corner of the sink. Recommend replacement of the cracked tile to prevent moisture damage to the wood sub surface.

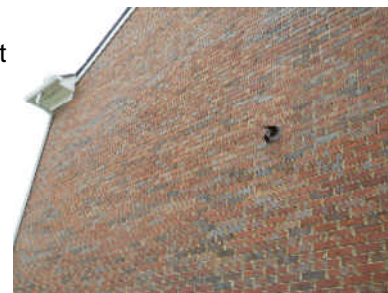
BATH VENTILATION: The vent cover, on the exterior is broken. Recommend replacing the vent cover to prevent insect and small animal intrusion.

23. The vent cover, on the exterior is broken. Recommend replacing the vent cover to prevent insect and small animal intrusion.
