PRECISION INSPECTIONS, LLC

Residential Property Inspection Report

Property Address: 1 My Street
Any Town, NC 00012

FILE #: 100525one.
DATE OF INSPECTION: 5-25-2010.
CLIENT NAME: Jack & Jill Hill.
INSPECTION SITE: My Street.
INSPECTION SITE CITY/STATE/ZIP: Any Town, NC 00012.

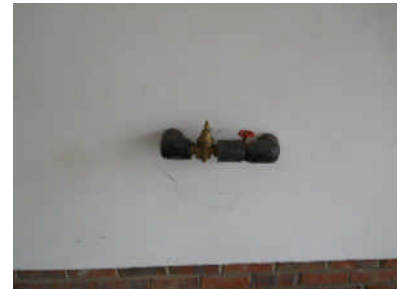
The main plumbing shut off valve is located in the garage.

CONDITION: The main line is functioning as intended. The valve was not tested.
